# Colvin Inspections

## Your Property Inspection Report

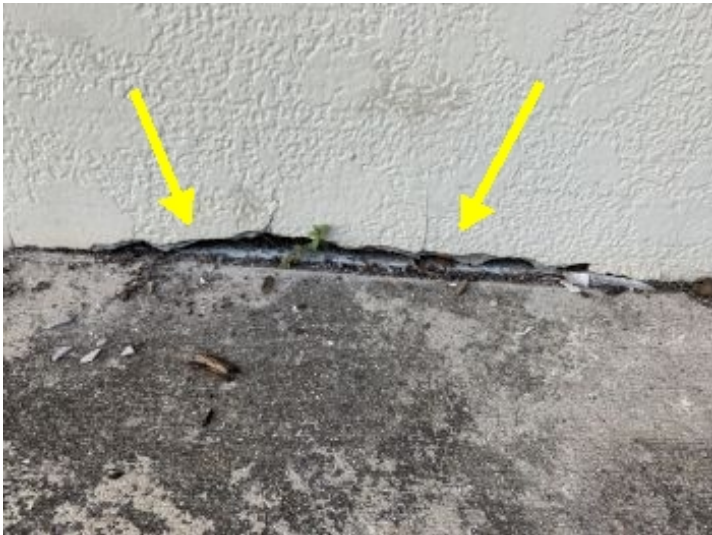
Hardi board used as siding for front storage area. Bottom is broken and starting to deteriorate

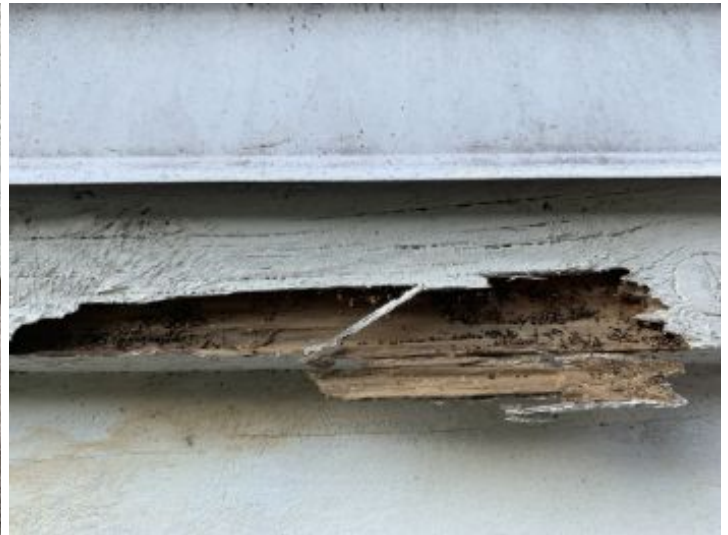
Some wood deterioration noted at front eave trim. Have repaired and inspected for wood-destroying insect damage.

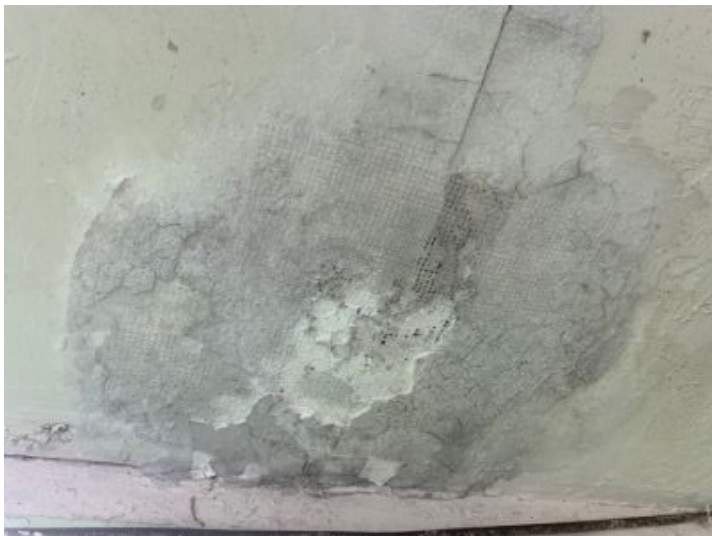
Eaves under front porch has been repaired with interior drywall compound.

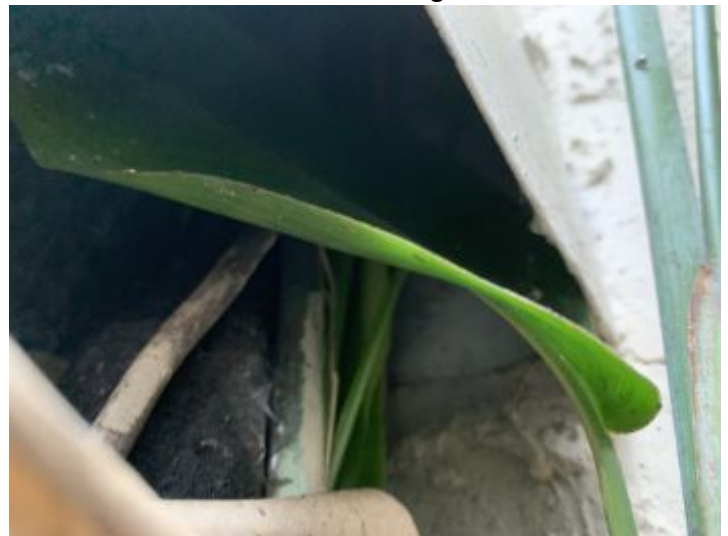
A/C Chase is not sealed. This acts as a highway for rodents and insects

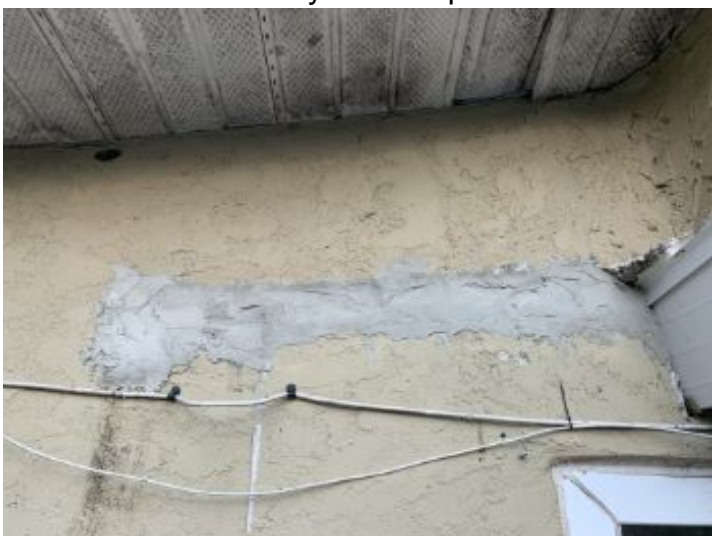
Stucco repair requires sealing and paint

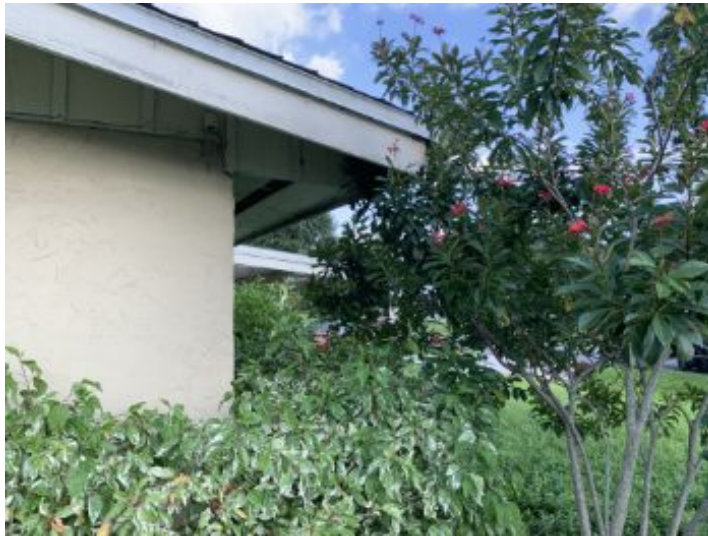
Trim trees that are in contact or proximity to home, as branches can abrade roofing or siding.

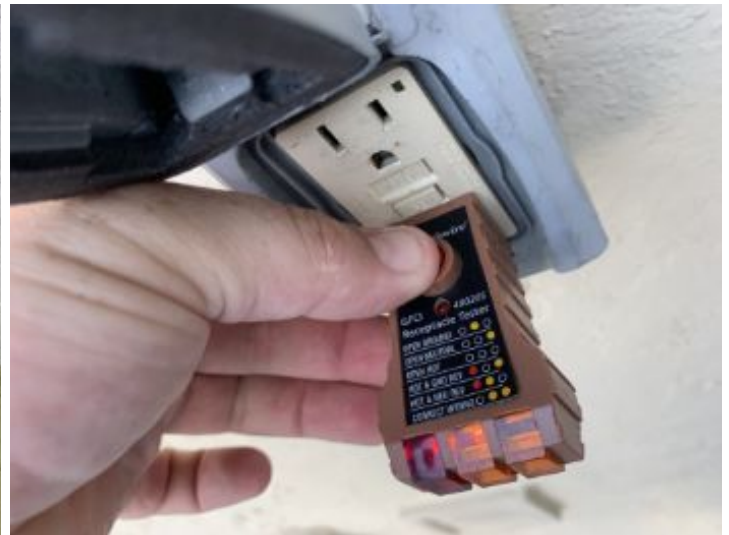
GFCI Trip fail, wired incorrect

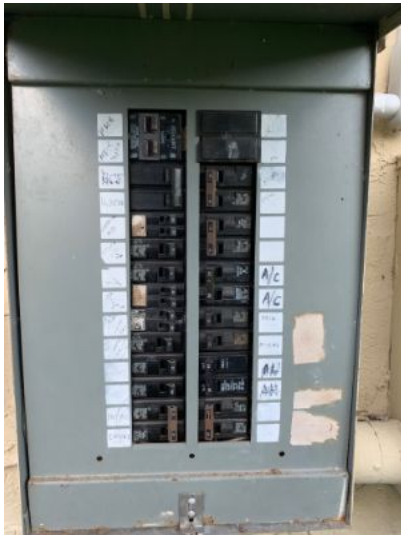
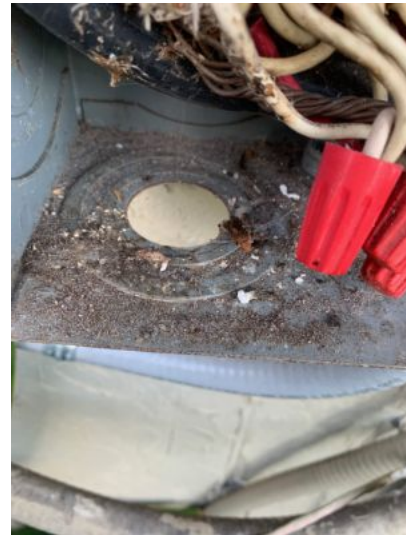
Knockouts need snap-in caps inside panel box. Should be installed to keep mice out of panel box and to avoid potential electrocution hazard.

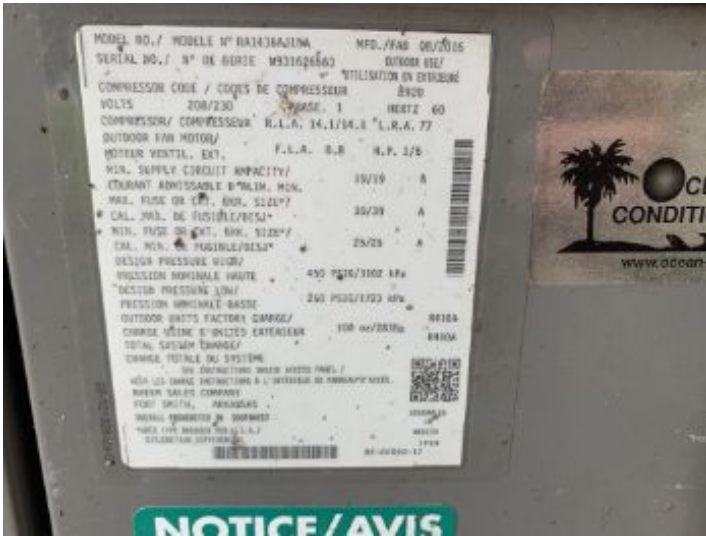
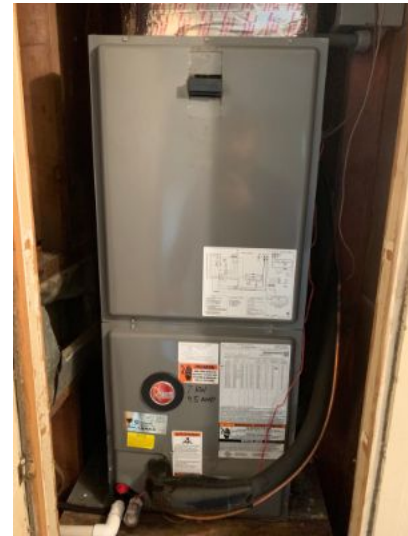
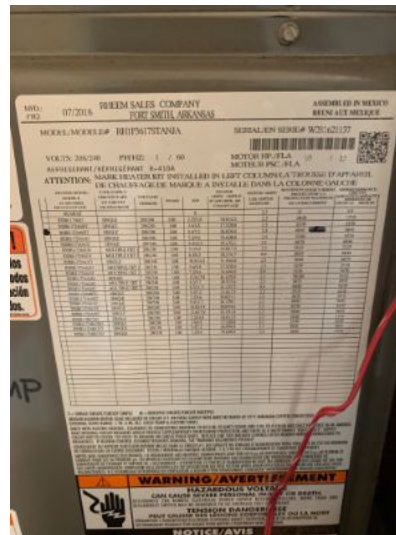
- Recommend installation of carbon monoxide alarm in the home, and monthly testing of smoke alarms to ensure proper operation.
- **Open permit with violations**
- **Electric Furnace: Last service date is over one year ago, or is unable to be determined. Although this unit appears to be operating properly from controls, there are areas which cannot be seen without specialized equipment and training. Furnace specialists recommend a complete inspection annually; consider having unit inspected by certified HVAC technician.**
